Frost Resistance of Cover and Liner Materials for Landfills and Hazardous Waste Sites

Edwin J. Chamberlain, Allan E. Erickson, and Craig H. Benson

December 1997

Special Report 97-29

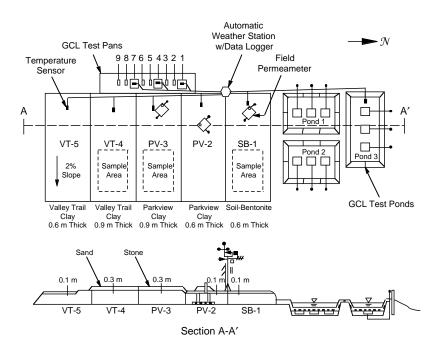
Figure 1. Plan view of the test site. Test pads containing Parkview clay are labeled PV. Test pads containing Valley Trail clay are labeled VT. The test pad containing sand-bentonite is labeled SB.

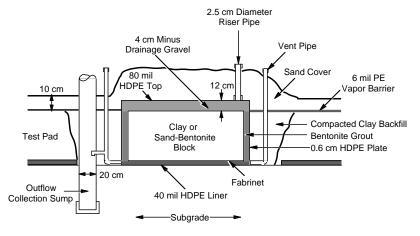
Figure 2 shows a section of the field permeameters. Construction consisted of carving soil away to leave an undisturbed 4- \times 4-ft (1.3- \times 1.3-m) block of clay or sand–bentonite. An HDPE box, open at top and bottom, was placed around the block of clay, then seamed at the bottom to the

Figure 2. Details of the field permeameters in the test pads.

underlying HDPE. Piping and filter material were installed that connected to the geonet drain (placed below clay before compaction), thus allowing water that seeps through the block of clay to flow to a sump for observation and possible measurement. The 4-in. (10-cm) space between the block of clay and the inside wall of the HDPE box was filled with bentonite grout to prevent side leakage. A layer of nonwoven geotextile was placed on top of the clay and covered with a layer of coarse, 2-in. (5-cm) or smaller washed gravel that filled the space between the top of clay and the top of the HDPE box. An HDPE lid was placed and seamed on top of the box. A 1-in.- (2.5cm-) diameter PVC riser pipe was placed at the high point of the lid to allow water to be added to the system and inflow of seepage to be measured.

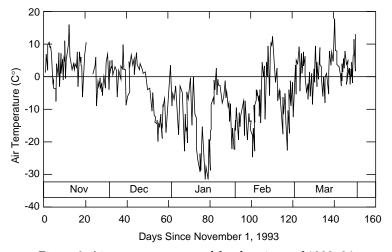
Figure 6. Air temperature record for the winter of 1993–94.

Temperatures at the site were monitored in the air and in the ground over two winters, 1992–93 and 1993-94, and recorded hourly. A typical air temperature plot is shown in Figure 6, and an example of a plot of the freeze and thaw depths during a winter is illustrated in Figure 7. Freezethaw cycling started in November of both winters. By mid- to late December, the freezing rate was steady. Frost reached the bottom of the test sections by mid- to late January and remained there for about a month. In mid-February, shallow, topdown freeze-thaw cycles started, and in mid- to late March, thawing began in earnest from both the bottom and top of the test pads. Thawing was complete by the first week of April in both winters. The test sections were frozen for about 3.5 months each winter. The freezing records for both winters show that, once freezing was established, little of the freeze-thaw cycling that occurred in the granular cover material reached the test materials.

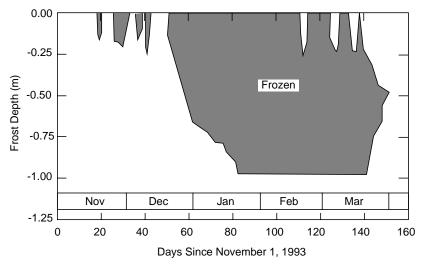
Figure 7. Example of the freeze and thaw depths during the winter of 1993–94.

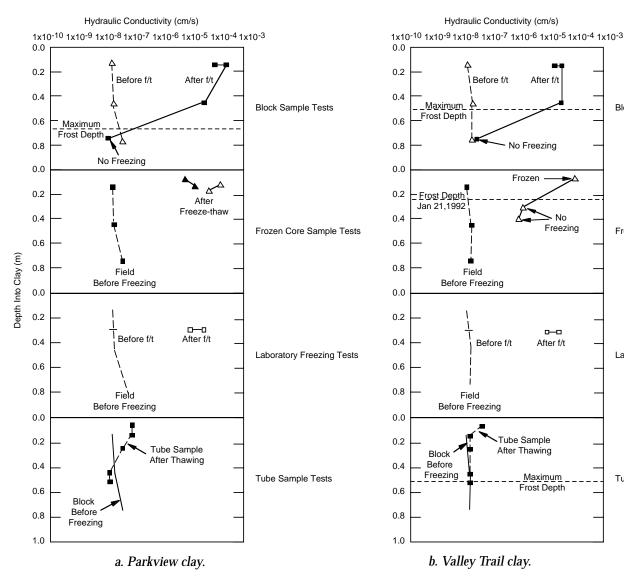
Figure 8. Summary of hydraulic conductivity test results.

Comparisons of our laboratory and field tests on the two natural clays (Parkview clay and Valley Trail clay) show that freeze-thaw cycles caused an increase in hydraulic conductivity of three to four orders of magnitude (Table 2 and Fig. 8). The increase in hydraulic conductivity for the Parkview clay was from about 3×10^{-8} cm/s to greater than 1×10^{-4} cm/s. For the Valley Trail clay, the increase was from about 2×10^{-8} cm/s to about 8×10^{-5} cm/s.

However, the hydraulic conductivities determined from test specimens sampled with the thin-walled tube after freeze-thaw (Fig. 8, bottom panels) do not agree at all with the other field and laboratory test results. The values for hydraulic conductivity after freeze-thaw were not significantly changed from the values obtained before freezing and thawing. It appears that the pressing of the thin-walled tube sampler into the dense clay matrix increases the stress on the soil and

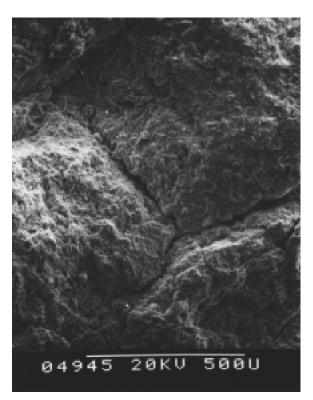
Figure 11. SEM photograph of a crack caused by freeze-thaw in Parkview clay.

This increase in hydraulic conductivity is attributed to the formation of cracks from ice lenses and shrinkage. Thin sections (Fig. 9) and half sections (Fig. 10) cut of these materials show the ice-filled cracks between aggregates of soil. A scanning electronic microscope (SEM) photograph (Fig. 11) shows further detail of a crack

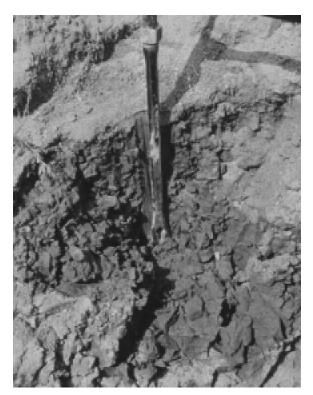
Figure 12. Test pit showing blocky soil structure caused by freeze-thaw cracking—Valley Trail test pad.

after thawing. Excavation in the test pads after thawing was complete exposed structures (Fig. 12) consisting of many block–aggregates, approximately 1 in.³ (1.6 cm³) in size, separated by vertical and horizontal cracks.

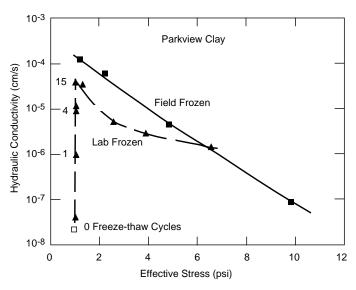
Figure 13. Impact of effective stress on the hydraulic conductivity of Parkview clay after freezing and thawing.

To show this stress effect, hydraulic conductivity tests were also conducted on test specimens at higher stress levels than normally used in the back-pressure permeameter—i.e., at stress levels up to 10 lb/in.² (69 kPa) in comparison with the 1 lb/in.² (6.9 kPa) effective stress level normally used in our tests. Figure 13 shows that increasing stress decreases the hydraulic conductivity of the Parkview clay and that about 12 lb/in.² (83 kPa) of stress is needed to decrease the hydraulic conductivity to its value before freezing.

The increasing stress test results also show where, in a landfill or hazardous waste site, freezing and thawing has its greatest impact. In covers, even with several feet of frost protection, the maximum effective stress will not generally exceed 3 or 4 lb/in.² (21 or 28 kPa), whereas the stress level in a clay liner can easily exceed 12 lb/in.² (83 kPa). The stress level in a cover will, thus, in most cases not be great enough to close the cracks and reduce the hydraulic conductivity to an acceptable value,

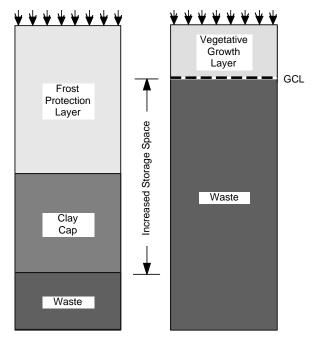
Figure 15. Increased storage space resulting from the use of a GCL and the elimination of the frost protection laver.

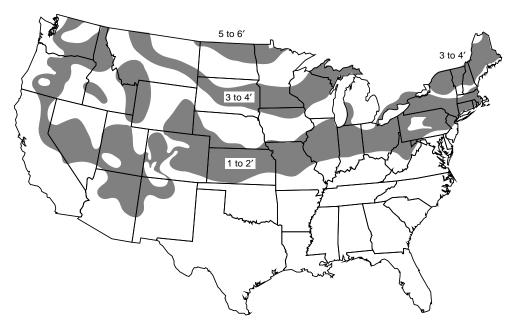
Figure 16. Thickness of protective soil layer required for compacted clay covers.
